# Facility Security Assessment

**Acme Corp**  
Hollywood, CA,  
United States

<b>Name</b>	<b>Facility Security Assessment</b>
<b>Dates</b>	February 16, 2025, to February 17, 2025
<b>Targets</b>	Acme Corp Headquarters Facility in Hollywood, CA

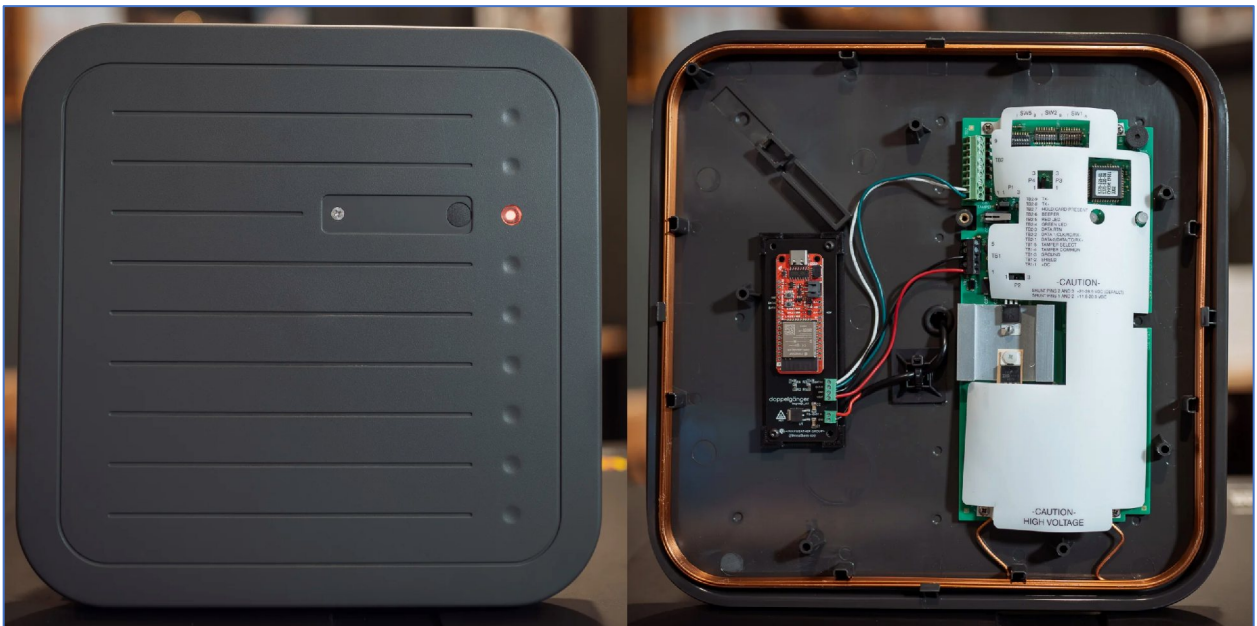
Figure 16: Doppelgänger RFID Longrange Cloning Device

On February 16, 2025, at approximately 08:33 AM, ioSENTRIX conducted on-site reconnaissance at the Corporate Centers at International Plaza campus. During this operation, ioSENTRIX leveraged longrange doppelgänger RFID cloning devices that were concealed inside of satchels that specifically targeted HID Prox access control cards. Doppelgänger weaponizes legitimate RFID readers to capture and interpret the card data. HID Prox Card II (H10301) is considered legacy and dangerous access control technology since it does not offer encryption making it trivial to capture cards using well known commercially available tooling.

ioSENTRIX recommends that Acme transition their internal access control cards to a solution that employs encrypted communication using proprietary keys (e.g., iCLASS SE / Seos with Elite Keys). Additionally, we recommend that Acme use access control cards that have a unique look that includes an employee photo, and a holographic marker. Doing so will reduce an attacker’s ability to identify the specific technology in use and make creating a replica substantially more difficult. In addition, Acme should ensure that all doors have proper latch protections. This should include adding magnetic locking mechanisms to the inside of the network closets to prevent the usage of UDT devices. Finally, ioSENTRIX recommends adding security cameras to all protected doors and the networking closets. Doing so will help triage any incident as well as provide law enforcement agencies with tangible evidence when considering criminal prosecution.
